NGFA Safety Tips: Manlifts

Manlifts in Grain, Feed and Processing Facilities

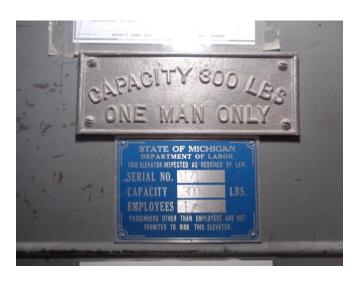
The car's cage must be structurally sound and totally enclose the operator.

Limit switches are located at each entry door and at the top and bottom of the rails. Limit switches located at each entry door prevent the manlift from operating when the door is open. Limit switches located at the top and bottom of the manlift's rails turn the manlift off when the car reaches the top or bottom of the shaft.

Manlift cars are also

equipped with operating controls that allow the operator to stop at individual floors manually or automatically. Some manlift cars are equipped with an emergency stop button that engages the brakes when the button is depressed.
